## Notes and Images

### ***Pendeford Mill Lane to Autherley Junction – alternative route***

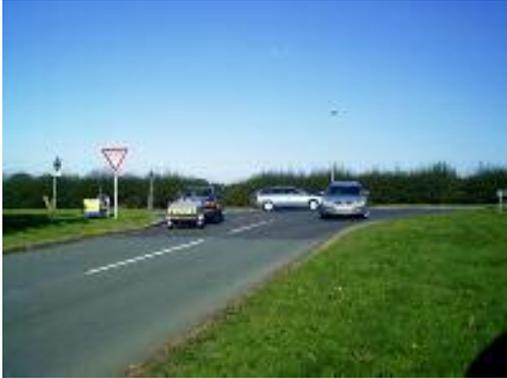
Image A: Pendeford Mill Lane from Barnhurst Lane. In order to access the cycle path on the far side, one has to cross the traffic at this busy junction. Barnhurst Lane is a straight road so traffic speeds tend to be high.

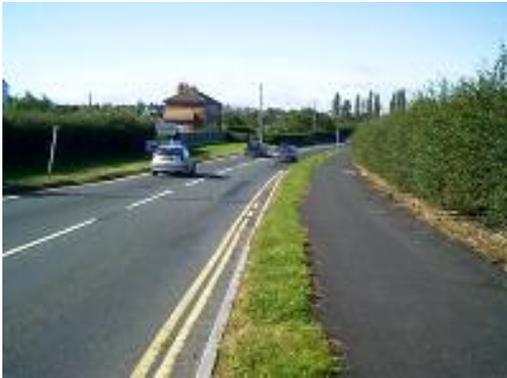
Image B: The cycle path on Pendeford Mill Lane, looking west towards Bilbrook. Barnhurst Lane is on the left. Route 811 west turns right off Pendeford Mill Lane and so the cycle path is on the correct side of the road; if one cycled on the road then it would be necessary to cross the traffic to turn right.

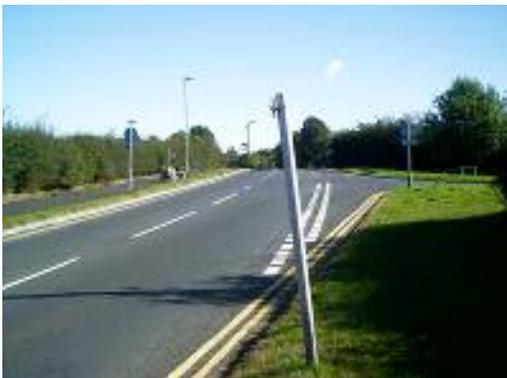
Image C: Looking east down Pendeford Mill Lane (which becomes Wobaston Road at this junction). Barnhurst Lane is on the right; the cycle path is on the left.

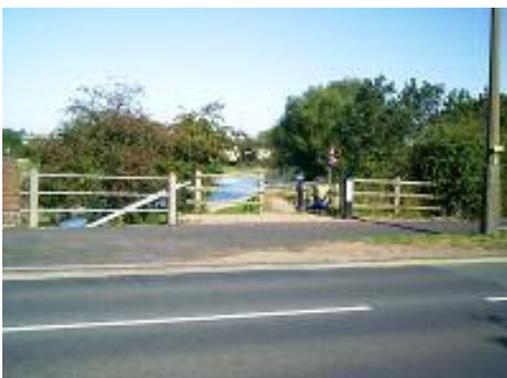
Image D: There is excellent access to the canal (Shropshire Union) from the cycle path on Pendeford Mill Lane / Wobaston Road. A new ramp has been provided and there is no barrier preventing access.

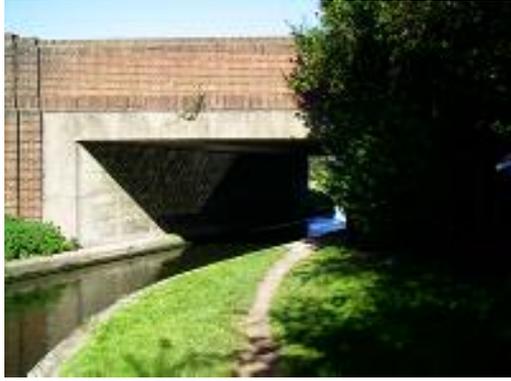
Image E: By using the canal towpath, one can go underneath the heavy traffic of Wobaston Road / Pendeford Mill Lane.

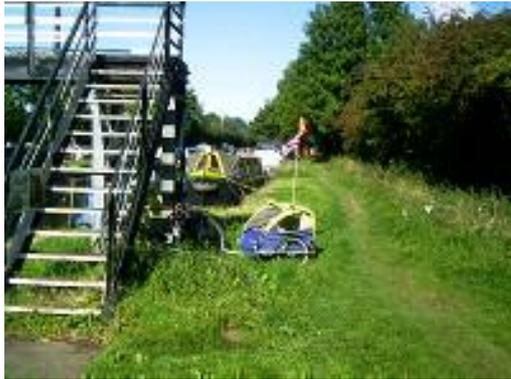
Image F: There are mooring rights by Wolverhampton Boat Club between Wobaston Road and The Drove way bridges. The towpath is very poor quality requiring a new surface to be laid. Boat owners may appreciate the improvements to the towpath which a Sustrans route would bring.

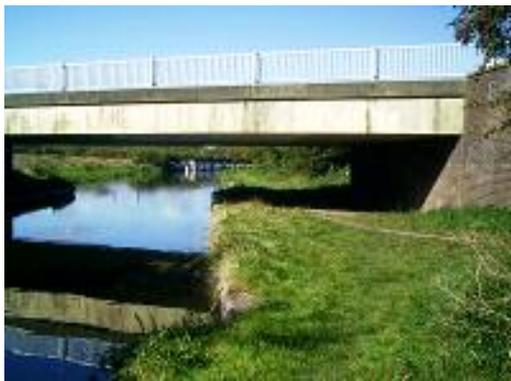
Image G: The towpath underneath the Drove way.

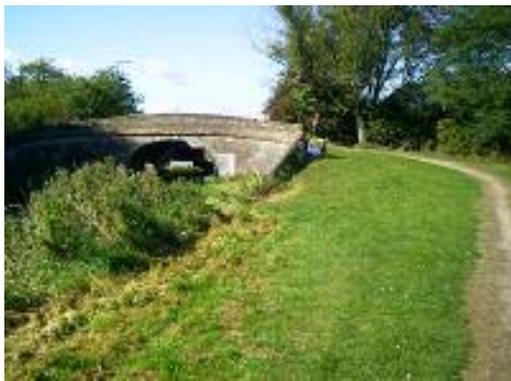
Image H: Bridge 3, a turnover bridge a few yards to the south of The Drove way bridge. The towpath under this bridge is very narrow but just rideable. It would be safer to take the route around the bridge but improvement to the path on the other side would be needed (Image I).

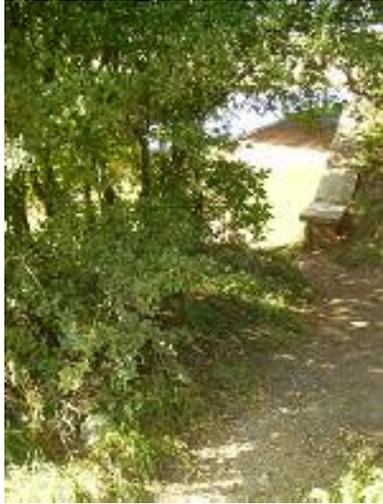
Image I: If the route around bridge 3 is to be used then this path will need to be widened and made less steep.

Bridge 3 has barrier-free access to the Droveaway. Signing from the Droveaway is needed.

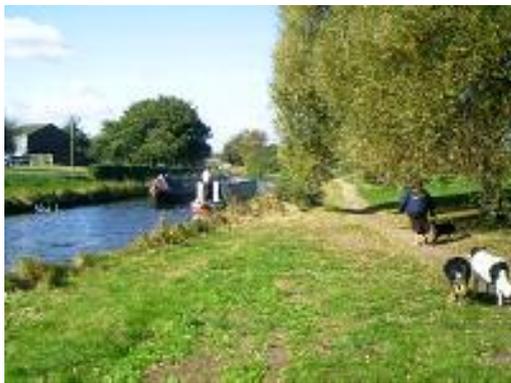
Image J: The path through the public open space between bridges 3 and 2. (The towpath is now on the opposite (west) side). The surface is reasonable but improvement is needed.

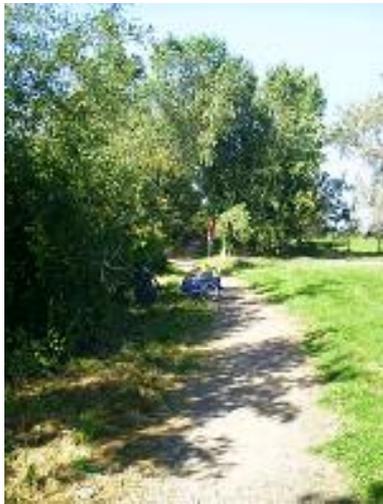
Image K: The path through the public open space from bridge 2 to the Staffordshire and Worcestershire Canal. The surface is reasonable but improvement is needed. (Image 6 shows this path from bridge 2 and image 12 shows this path leaving the Staffordshire and Worcestershire Canal).
