National Cycle Network Route 81
Report on Signing in Wolverhampton

May 2006

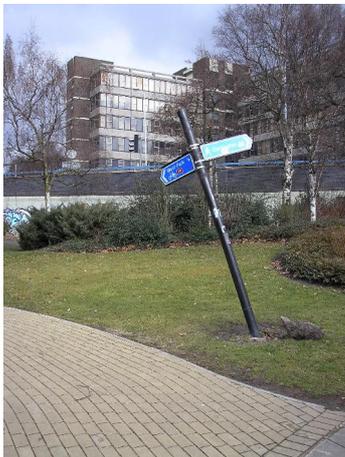
Picture 1. Darlington Street Island, subway

1. Pavement between Railway Drive and Lichfield Street: This is now shared use, and the two small “No Cycling” discs should be removed.
2. Darlington Street Island: Sign in subway area has been pushed out of position. **(Picture 1).**

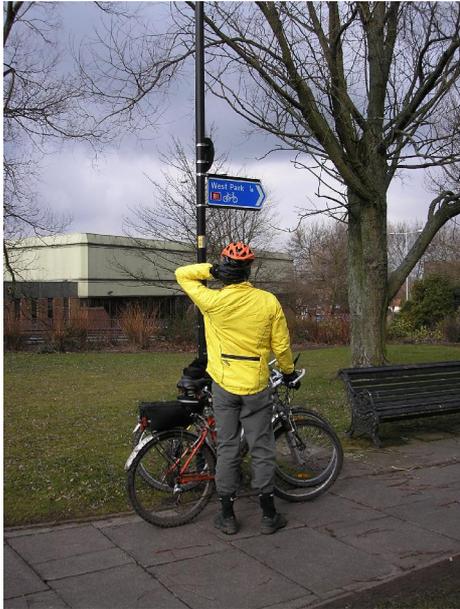
Picture 2. Darlington Street Island, exit from subway

3. Darlington Street Island: At the exit from the subway, a route sign to “West Park” points right and along the gardens in the central reservation of Ring Road St Andrews, but this is not the crossing point. A cyclist following this sign to the point opposite Park Crescent would find the Ring Road separated by steel barriers. The sign should point back and left towards the toucan which is the actual crossing point. It may not be possible to correct this by means of temporary Ranger Signs, other than by completely removing or covering the sign. This should be replaced with a new left-pointing sign as a matter of urgency. (Picture 2).

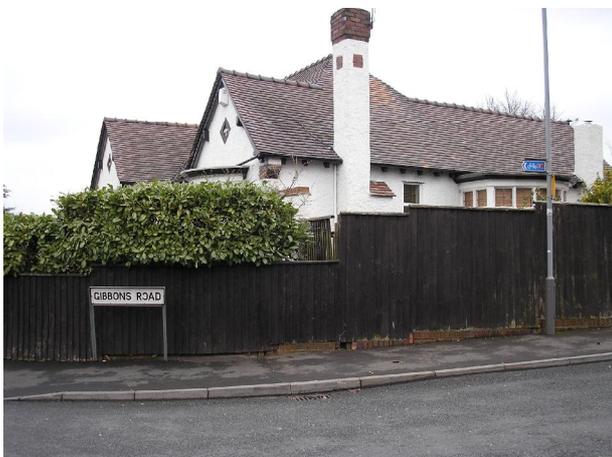
Picture 4. Bottom of Gibbons Road, right-hand side

5. Gibbons Road / Crowther Road mini-roundabout: The sign at the bottom end of Gibbons Road, right-hand side, pointing towards the mini-roundabout, serves no purpose. (Picture 5). A sign indicating the required right turn at the roundabout is needed (see comment on Picture 6 following).

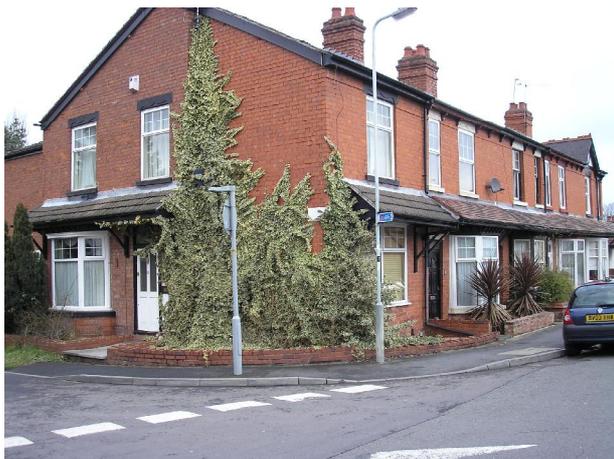
Picture 6. Crowther Road, after mini-roundabout

At the mini-roundabout itself, there is a sign serving for the inbound direction, pointing up Gibbons Road. **(Picture 6)**. A further sign should be added here for the outbound direction, pointing right along Crowther Road. The two together would clearly indicate that the route turns here.
